## **NOTICE OF DECISION TAKEN BETWEEN MEETINGS – (DD06 23) HIGH-RISK TREE WORKS AT CRABBLE ATHLETIC GROUND**

# Invicta Arboriculture

Our Ref: IA23/673

You have instructed me to undertake a visual inspection and risk assessment of the mature Beech trees located within the grounds of Crabble Sports Ground, Crabble Road, Dover and to provide an arboricultural report on their structural and physiological condition and to make recommendations for their immediate and/or future management due to concerns you have over their structural integrity.

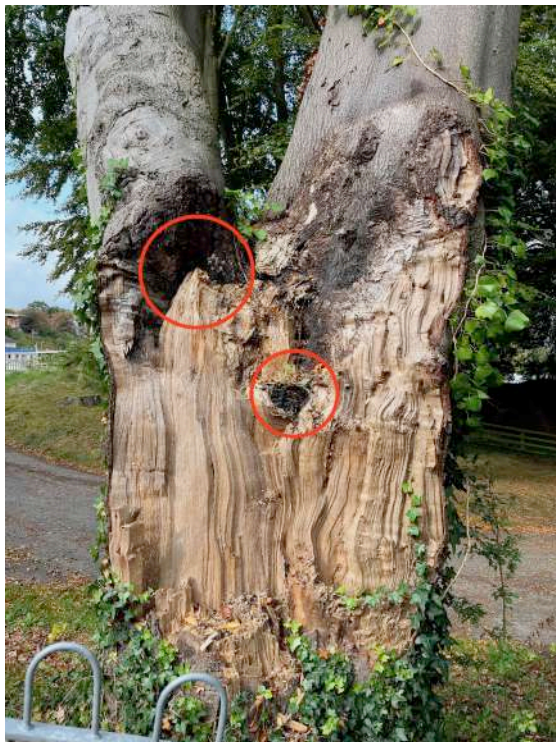
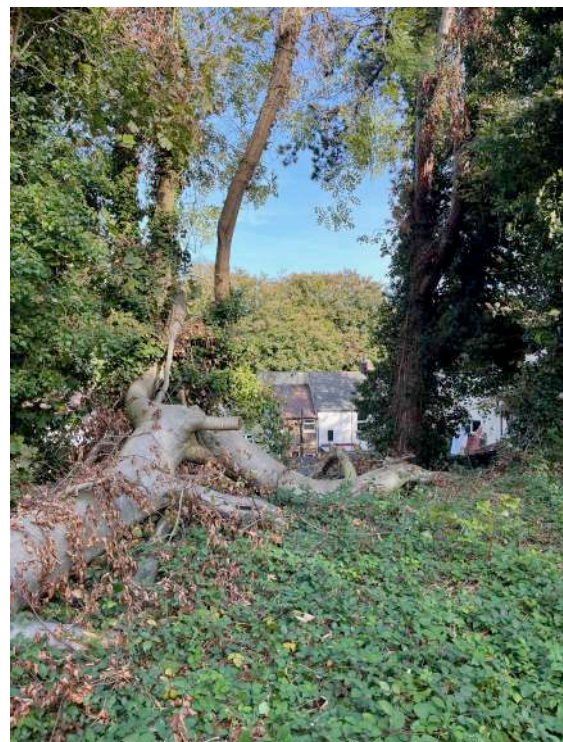
The trees are a striking visual feature of the site, however their structural integrity is being increasingly compromised, with many of them beginning to fail either partially or wholly and with increasing regularity. Recent examples of this have occurred within the wooded copse at the eastern end of the site with one of the trees failing completely and falling into the garden of an adjacent property destroying the shed and boundary fence-line. Upon closer inspection of the fallen tree it was obvious that the failure occurred as a result of a structurally defective fork that was also compromised by the presence of the fungal pathogen *Kretzschmaria deusta*. Whilst the structurally defective fork would have been observable, the fungal pathogen within would not have been.

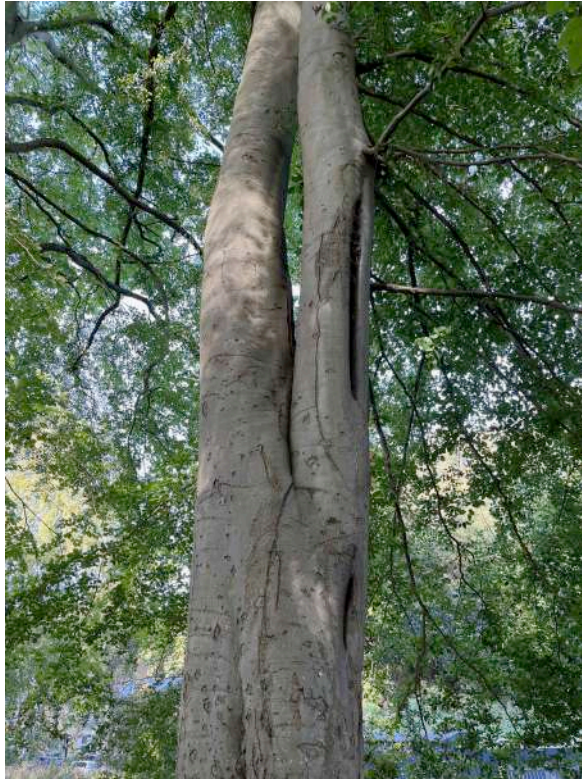
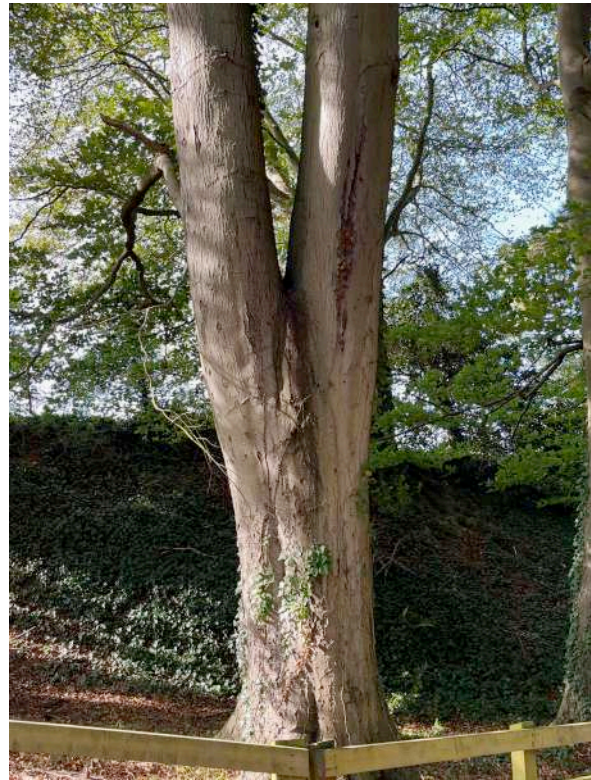
Fungal pathogens aside, a visual inspection of the trees revealed that many of the Beech trees present have observable structural defects such as tight forks, weak unions, un-occluded cavities, pockets of decay and exposed shallow root systems that will in time become compromised and as such are considered to pose an increasing and unacceptable risk to residents, pedestrians, and motorists within Crabble Avenue and those accessing the sports ground via the eastern wooded copse. I include two photographs below showing typical examples of the sub-optimal structural features that many of the trees present display.

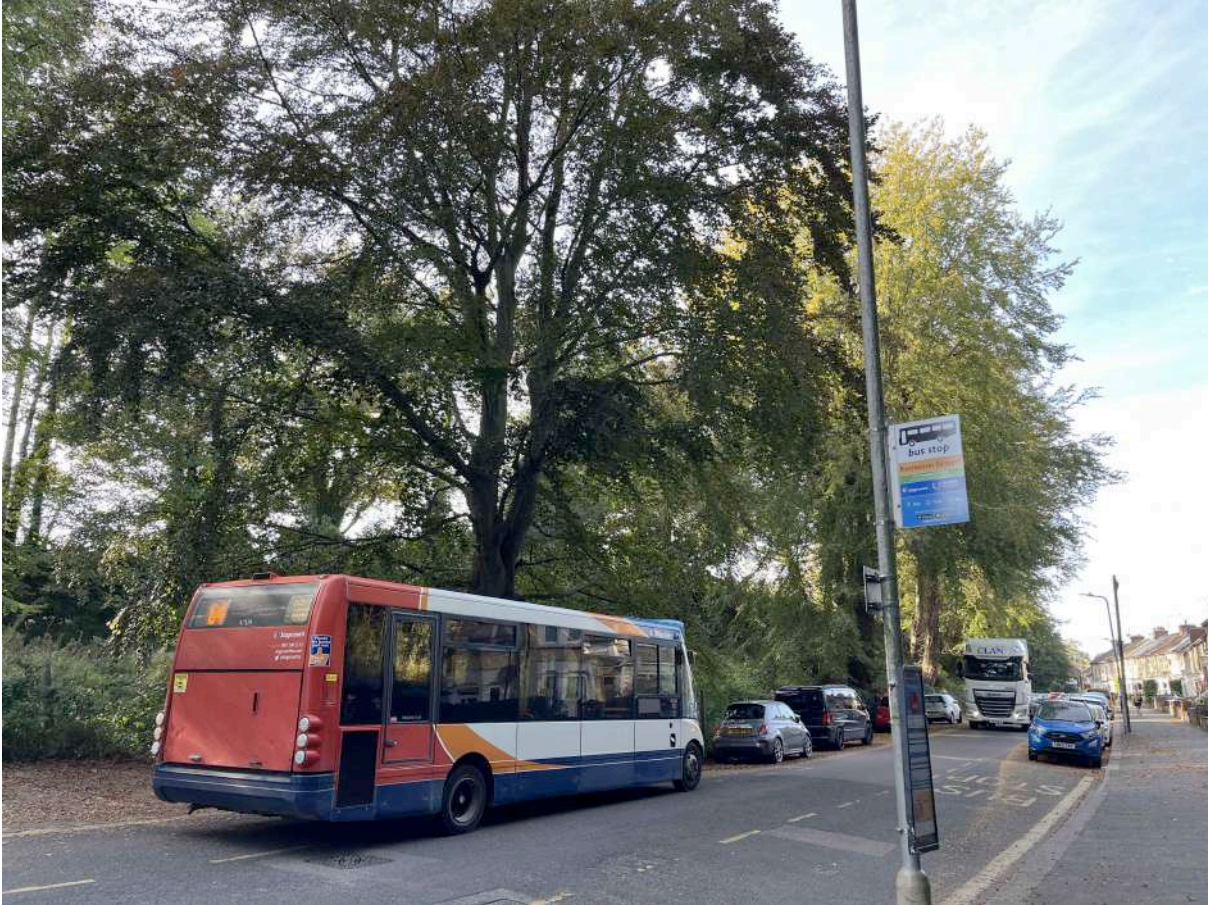
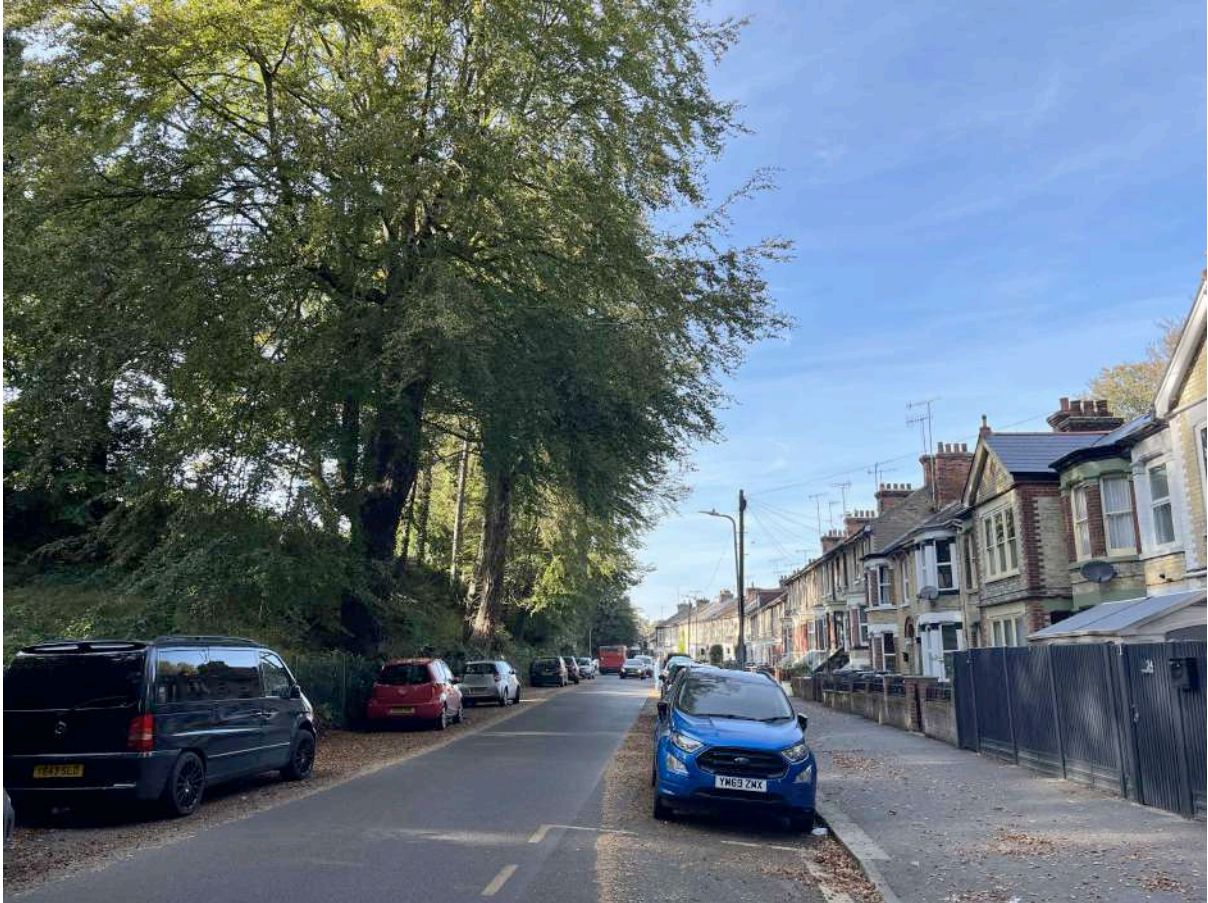
The trees located immediately adjacent to Crabble Avenue have been measured and stand between fifteen and twenty metres in height. A separation distance of only ten metres exists between the residential properties opposite, placing the trees well within falling distance of them, which understandably leads to increased anxiety for the residents.

Dover District Council has been spending an increasing amount of time, resource and finance in dealing with the Beech trees at Crabble Sports Ground in a reactive manner and as such a management plan for the site is proposed that will see the removal of fifteen roadside trees from Crabble Avenue and the twenty-one trees that form the wooded copse to the east, with a robust and diverse re-planting program prepared by the council that mitigates the loss of the Beech trees and provides the site with continuity tree cover for decades to come. The risk posed by the trees along Crabble Avenue and within the wooded copse has simply become unacceptable to the District Council with whom the duty of care rests.

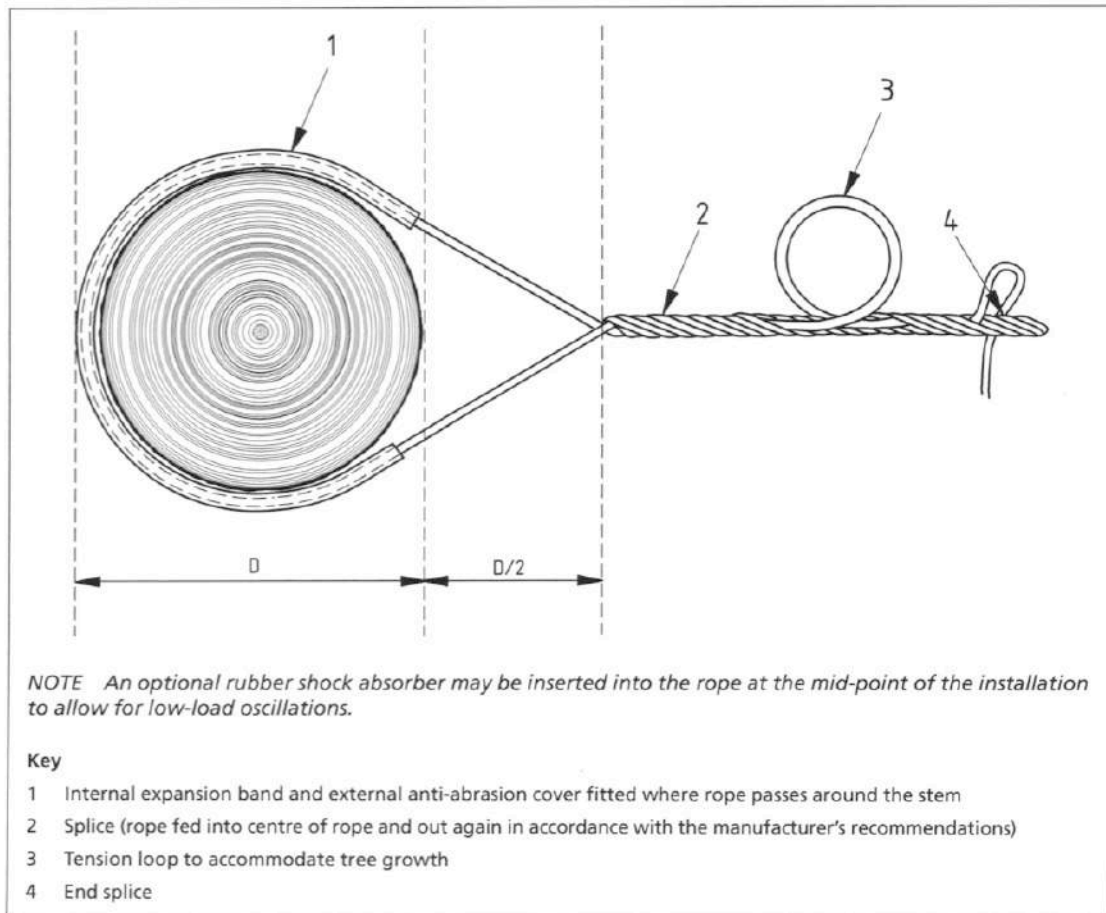
Figure D.2 Diagrammatic illustration of components used in a non-invasive restraint system: monofilament polypropylene hollow rope system

The exception to the above is the single Beech tree that stands at the entrance to Crabble Sports Ground off Crabble Road. This large, fully mature specimen tree stands at twenty-five metres in height with a canopy spread of ten metres to all four cardinal points and supports a full, wide spreading canopy that dominates the western boundary of the site. This tree, like those referred to above also has a number of noticeable structural defects; most notably the tight fork within the base of the large diameter (>300mm) north east facing stem arising at three metres above ground level along with numerous large diameter (>150mm) over-extended branches throughout its canopy. In addition to this there are three immature *Ganoderma spp* fungal fruiting bodies present at the base of the tree on the south-western and eastern sides.

Whilst the presence of the immature decay fungi currently poses no significant risk, it is important to reduce the loading within the trees canopy to safeguard the sub-optimal structures referred to above. A prescription is therefore made for the overall reduction of the height of the tree by four metres and its lateral spread by a maximum of three metres. The Beech at the entrance to the sports ground occupies an extremely exposed position to which it has adapted to over many years. The prescribed works are considered to be in accordance with good arboricultural practice. In addition to the overall reduction of the trees canopy a further recommendation is made for the installation of a non-invasive flexible brace to add

further support to the north-east facing stem. The non-invasive flexible brace should be installed in accordance with Figure D.2 BS3998:2010 and is reproduced below for reference. Bracings with an eight tonne rating are recommended.
