Invicta Arboriculture

Our Ref: IA23/673

You have instructed me to undertake a visual inspection and risk assessment of the mature Beech trees located within the grounds of Crabble Sports Ground, Crabble Road, Dover and to provide an arboricultural report on their structural and physiological condition and to make recommendations for their immediate and/or future management due to concerns you have over their structural integrity.

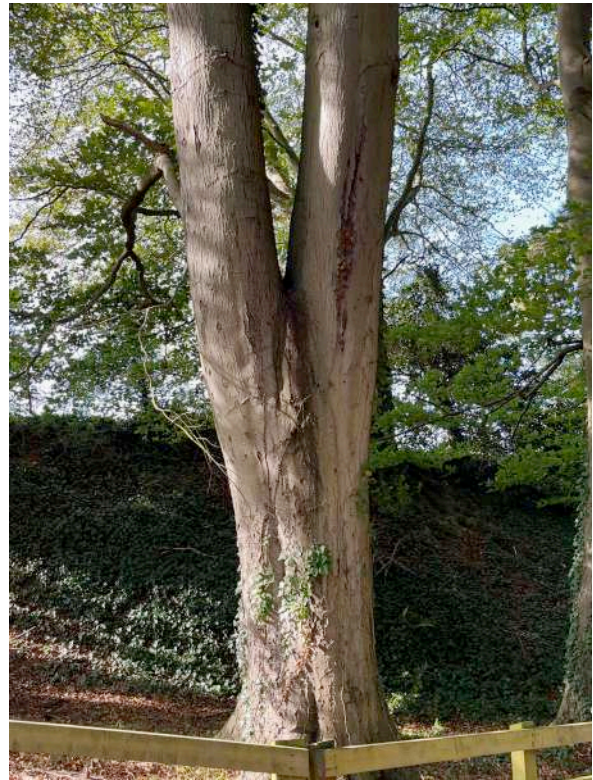
Fungal pathogens aside, a visual inspection of the trees revealed that many of the Beech trees present have observable structural defects such as tight forks, weak unions, un-occluded cavities, pockets of decay and exposed shallow root systems that will in time become compromised and as such are considered to pose an increasing and unacceptable risk to residents, pedestrians, and motorists within Crabble Avenue and those accessing the sports ground via the eastern wooded copse. I include two photographs below showing typical examples of the sub-optimal structural features that many of the trees present display.

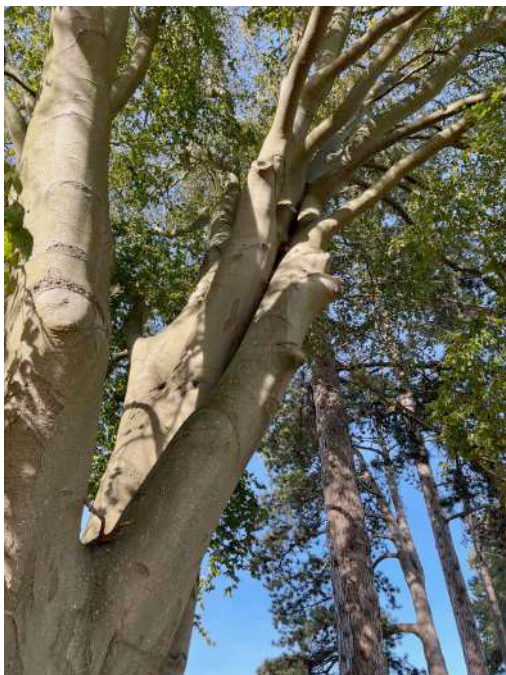
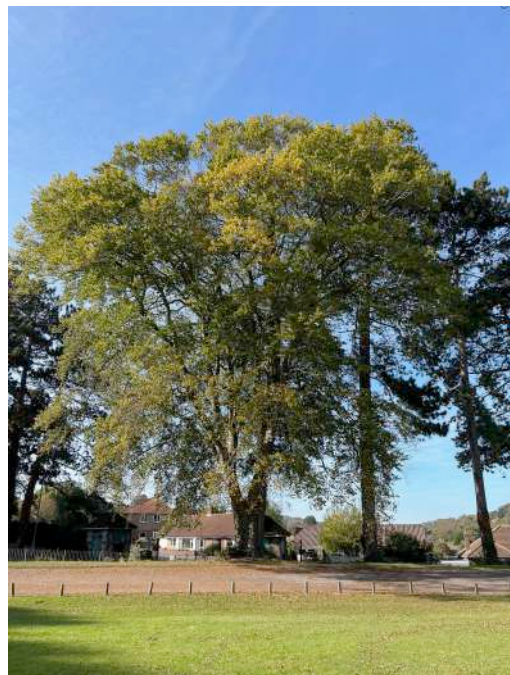
The exception to the above is the single Beech tree that stands at the entrance to Crabble Sports Ground off Crabble Road. This large, fully mature specimen tree stands at twenty-five metres in height with a canopy spread of ten metres to all four cardinal points and supports a full, wide spreading canopy that dominates the western boundary of the site. This tree, like those referred to above also has a number of noticeable structural defects; most notably the tight fork within the base of the large diameter (>300mm) north east facing stem arising at three metres above ground level along with numerous large diameter (>150mm) over-extended branches throughout its canopy. In addition to this there are three immature *Ganoderma spp* fungal fruiting bodies present at the base of the tree on the south-western and eastern sides.

Tight union with included bark at eight metres above ground level

Immature Ganoderma fungal brackets evident at base of tree on north east and south western sides

The highest risk is the structural failure of the north east facing stem

Whilst the presence of the immature decay fungi currently poses no significant risk, it is important to reduce the loading within the trees canopy to safeguard the sub-optimal structures referred to above. A prescription is therefore made for the overall reduction of the height of the tree by four metres and its lateral spread by a maximum of three metres. The Beech at the entrance to the sports ground occupies an extremely exposed position to which it has adapted to over many years. The prescribed works are considered to be in accordance with good arboricultural practice. In addition to the overall reduction of the trees canopy a further recommendation is made for the installation of a non-invasive flexible brace to add
