Subject:	WORKS TO ST JAMES'S CHURCH, DOVER
Meeting and Date:	Cabinet - 4 February 2019
Report of:	Roger Walton, Strategic Director (Operations and Commercial)
Portfolio Holder:	Councillor Trevor Bartlett, Portfolio Holder for Property Management and Environmental Health
Decision Type:	Non-Key
Classification:	Unrestricted

Purpose of the report: To alert Cabinet to the present condition of St James's church in Dover; to advise on the work needed to stabilise and conserve the structure; and to seek approval to proceed with this work.

Appendix 1:

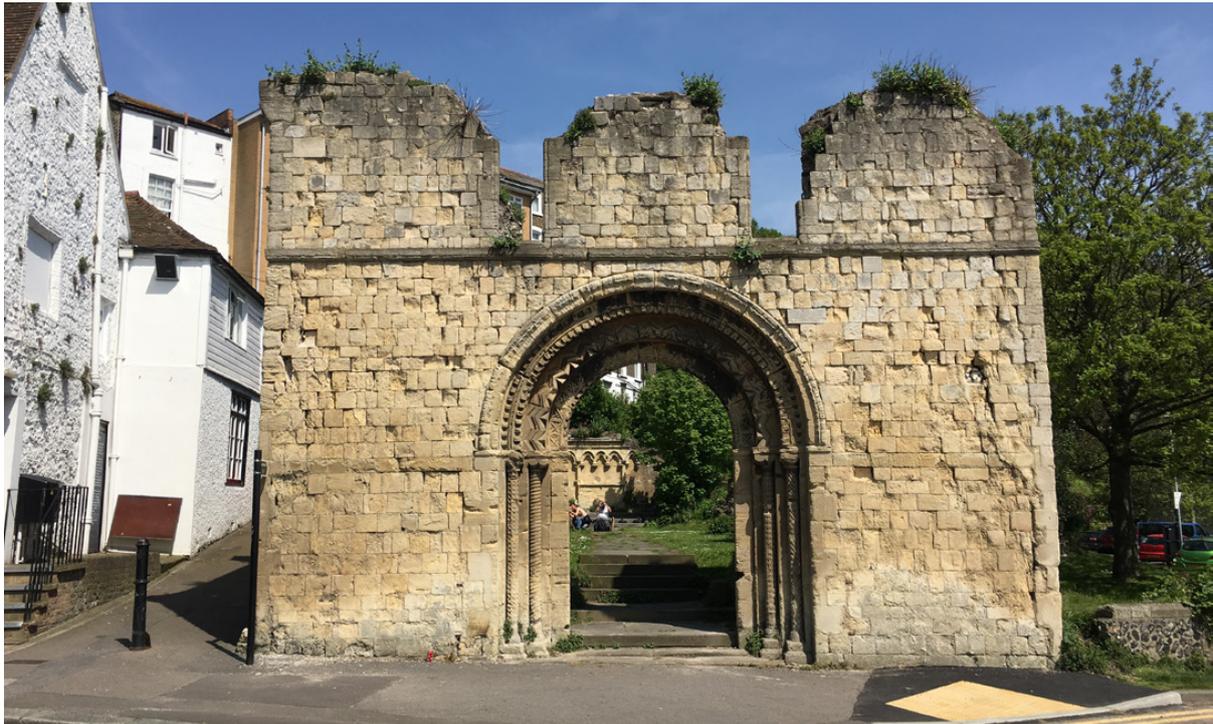
- 3.2 Proper repair will require substantial renewal of stone because, during the various campaigns of adaptation and repair that have gone before, parts of the fabric have become structurally disjointed. This, combined with natural material erosion, establishes parameters that do not readily lend themselves to the generally accepted monument repair methods, such as inserting wall ties, grouting and mortar consolidation. In order to achieve a long-lasting repair, it is likely to be necessary to replace a high proportion of masonry in key locations. The quoins to the North Tower and the North and South returns of the West elevation are in particular need of structural repair.

West Elevation: note cracking to right hand side of elevation

- 3.4.2 Purcells have also identified that the following works are necessary within 12 months of the date of the report: Clean out & re-point cracks to abutment of West elevation with North and South returns. Monitor for further cracking as a sign of continuing structural movement; Re-point all loose and open joints generally, including deep pointing to voids; Remove all remaining vegetation at high level; Re-bed all loose capping and high-level ashlar masonry to the North Tower and West elevation; Replace existing cementitious capping with new lime flashing or green capping as appropriate (note: green cappings are best installed at the onset of autumn). All work will be subject to obtaining scheduled monument consent and any necessary Planning consents.

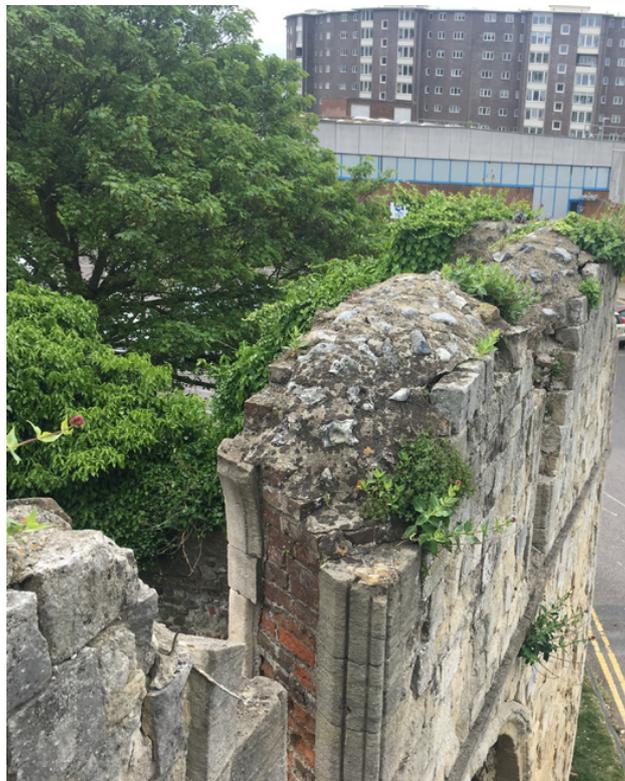
Typical view of damage to top of historic walls.

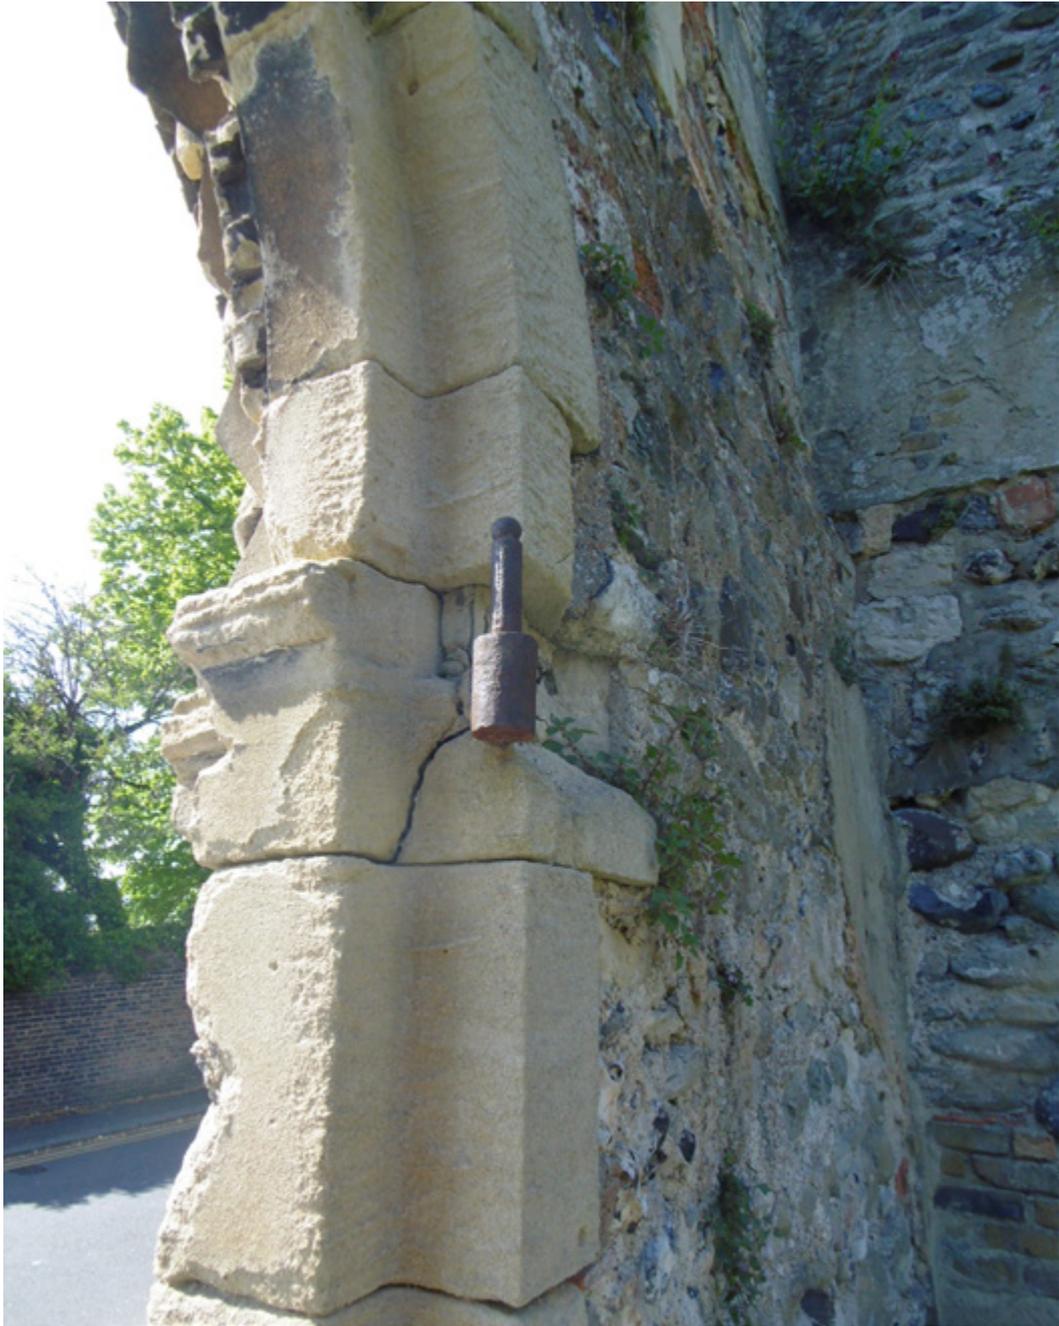
Corroding Ironwork Spalling Masonry
