DOVER DISTRICT COUNCIL

KEARNSEY ABBEY AND RUSSEL GARDENS – ORNAMENTAL POND SLAB INVESTIGATION

JOB REFERENCE: L/2673/22/WDT

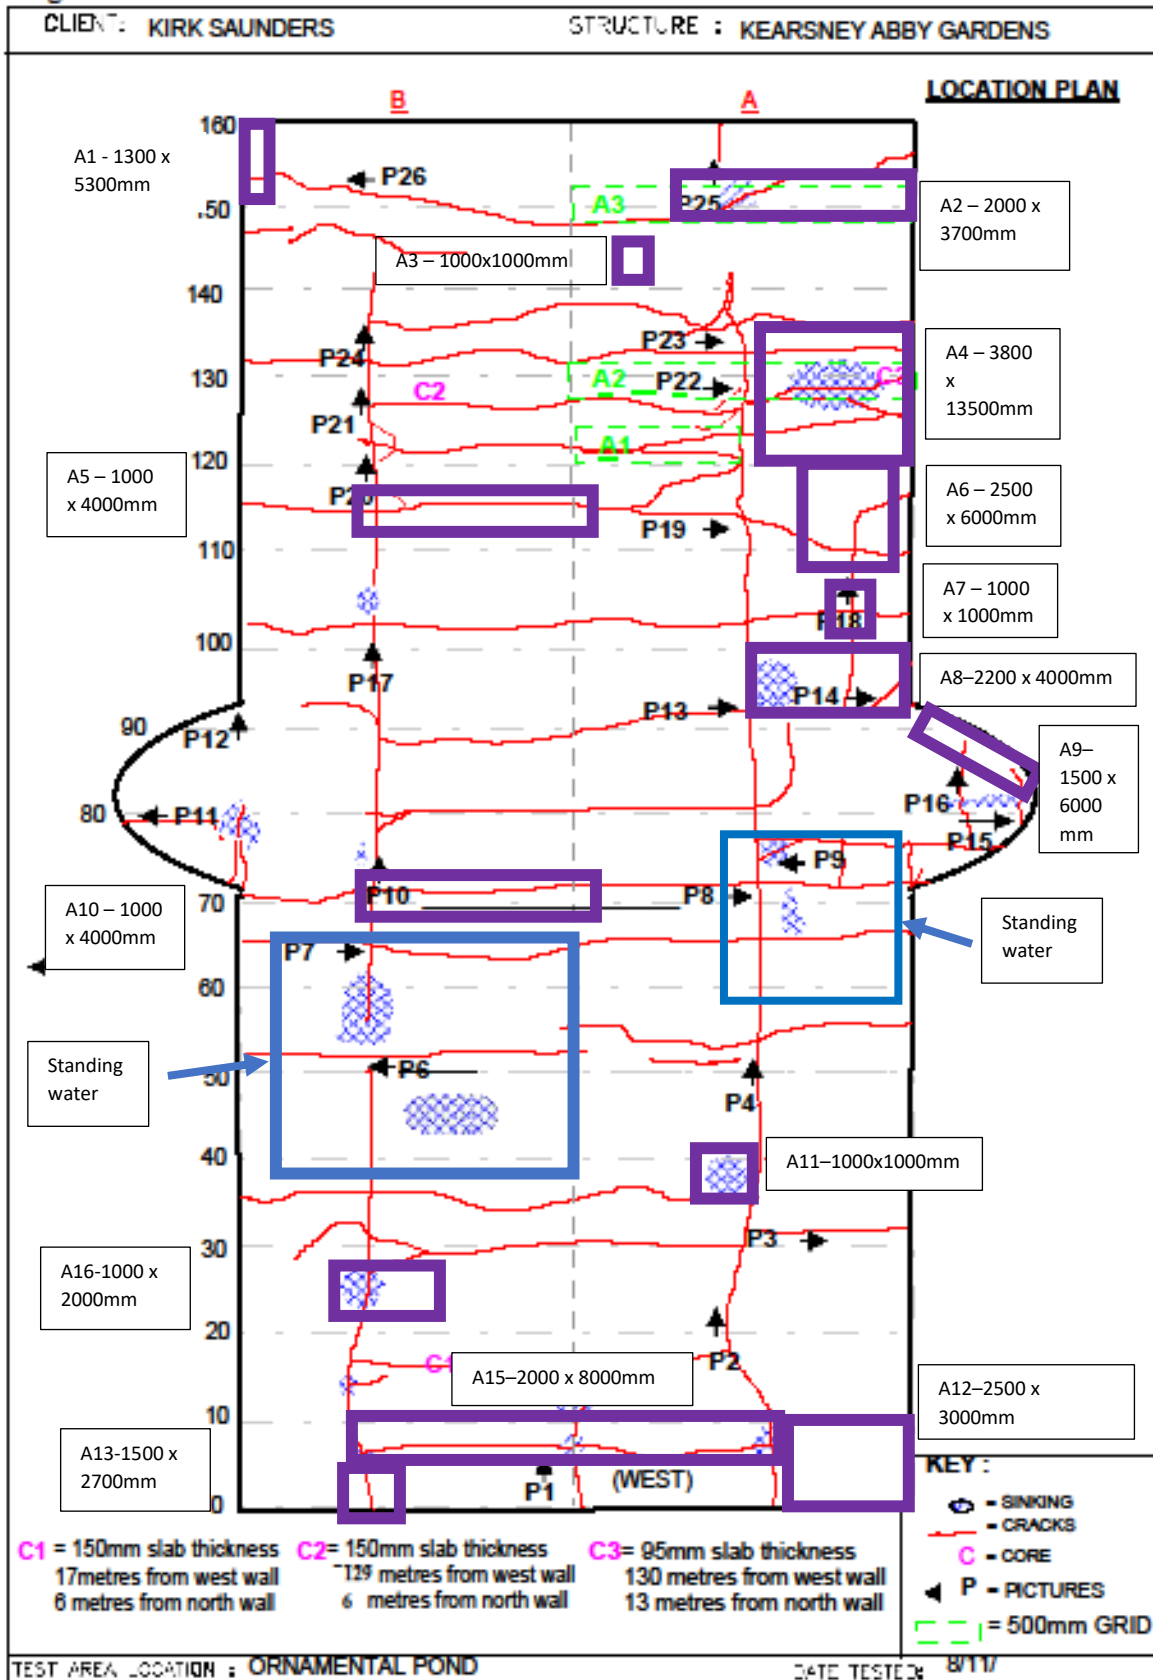
Fig 1

Record Drawings and Voidage Locations
Not to Scale

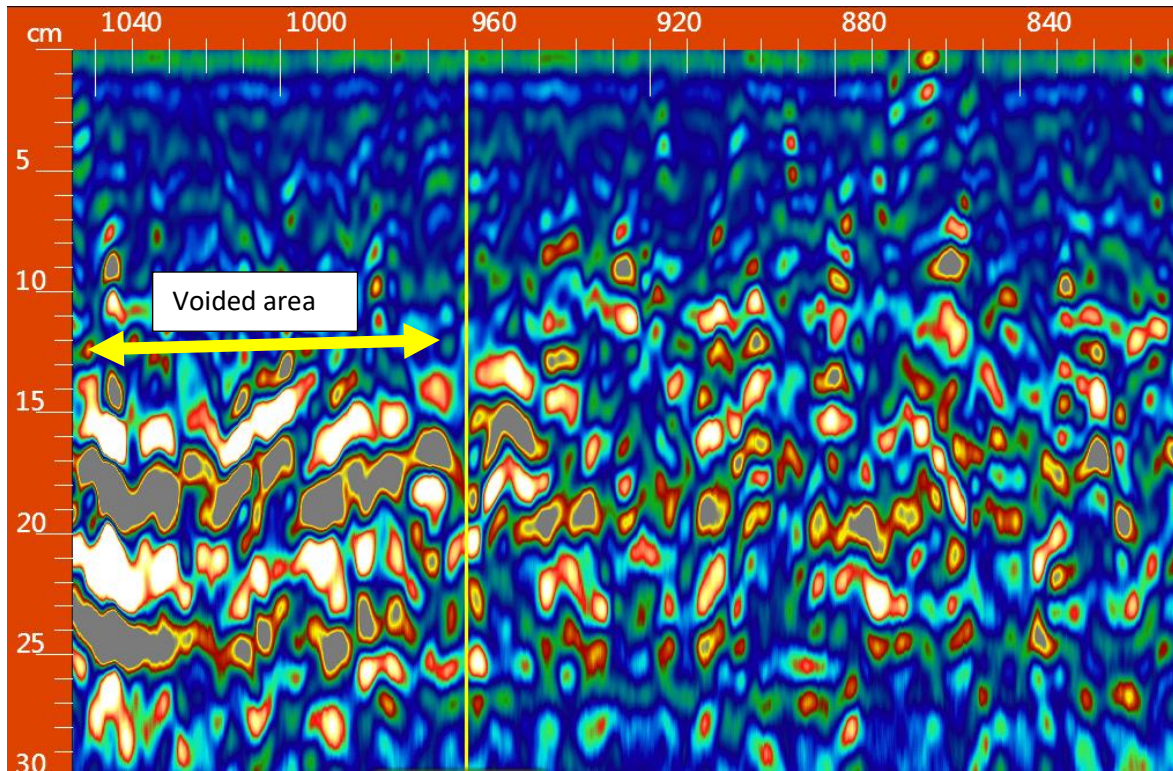
Scan 1 – Showing voidage to edge of area A4

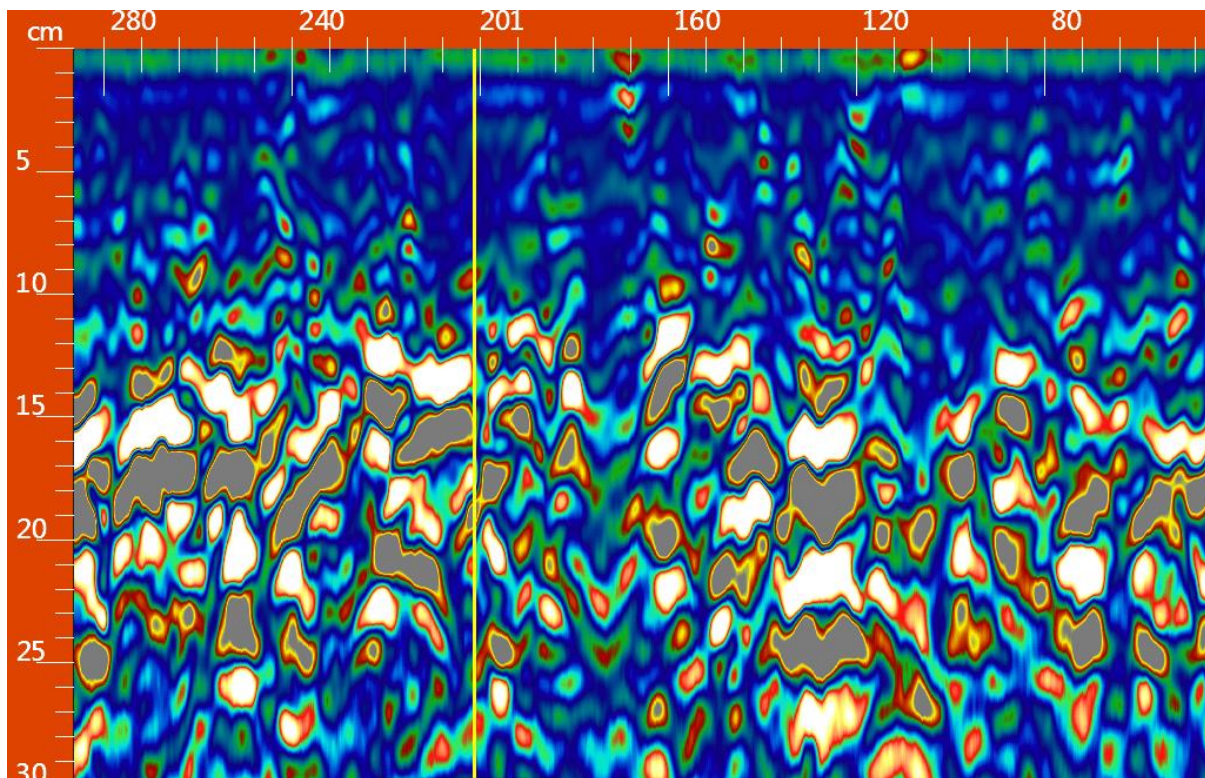
Scan 2 – Showing full voidage beneath slab to the centre of area A4

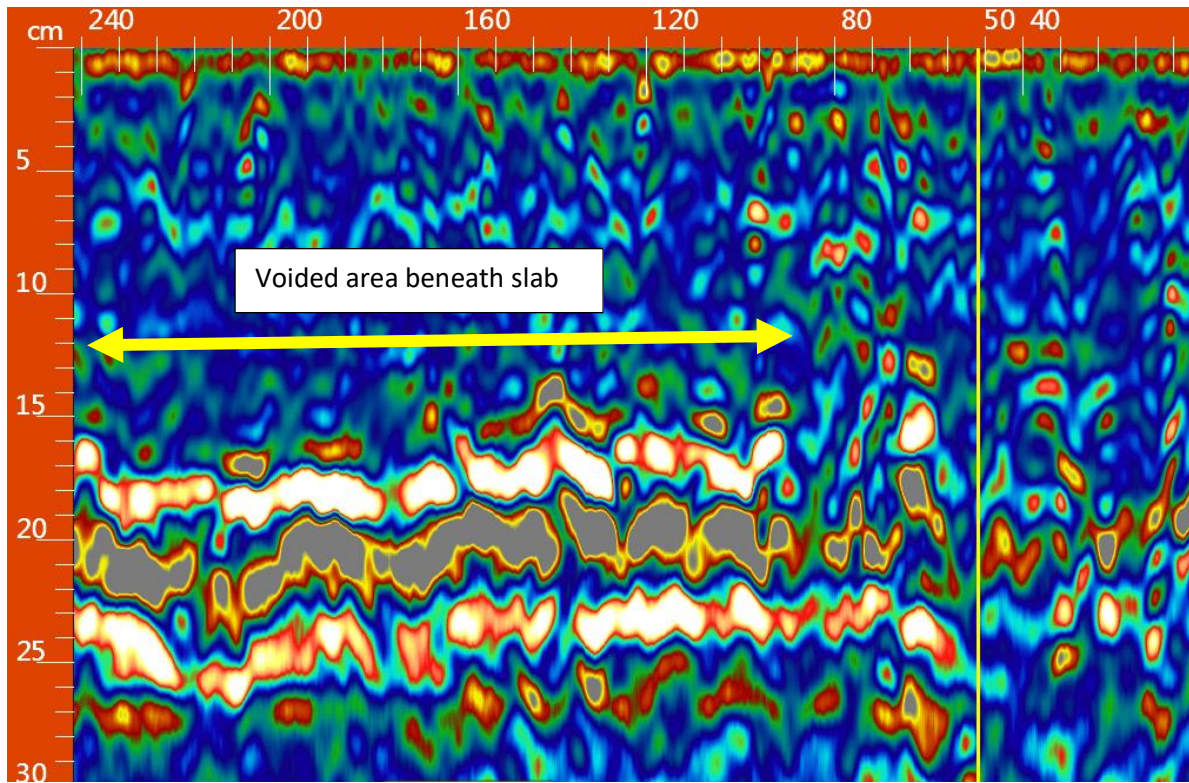
Scan 3 – Showing voidage to area A1

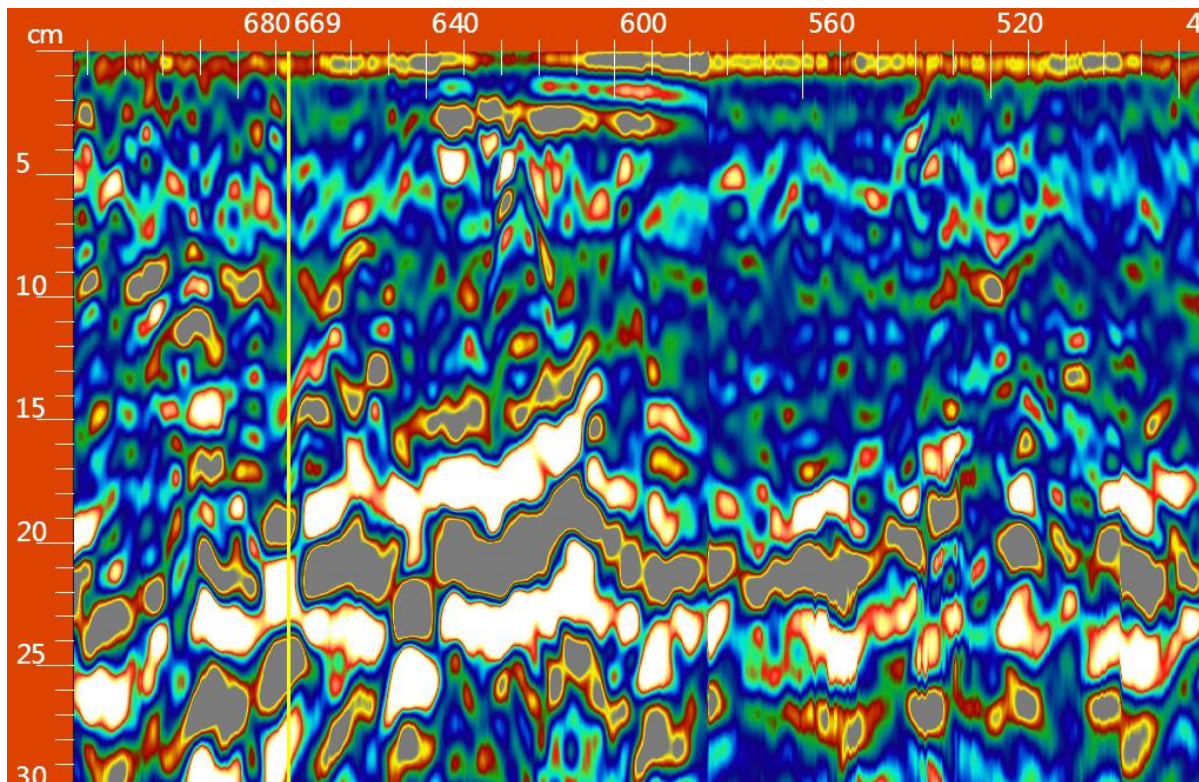
Scan 4 – Showing full voidage beneath slab to area A9 adjacent to wall of pond.

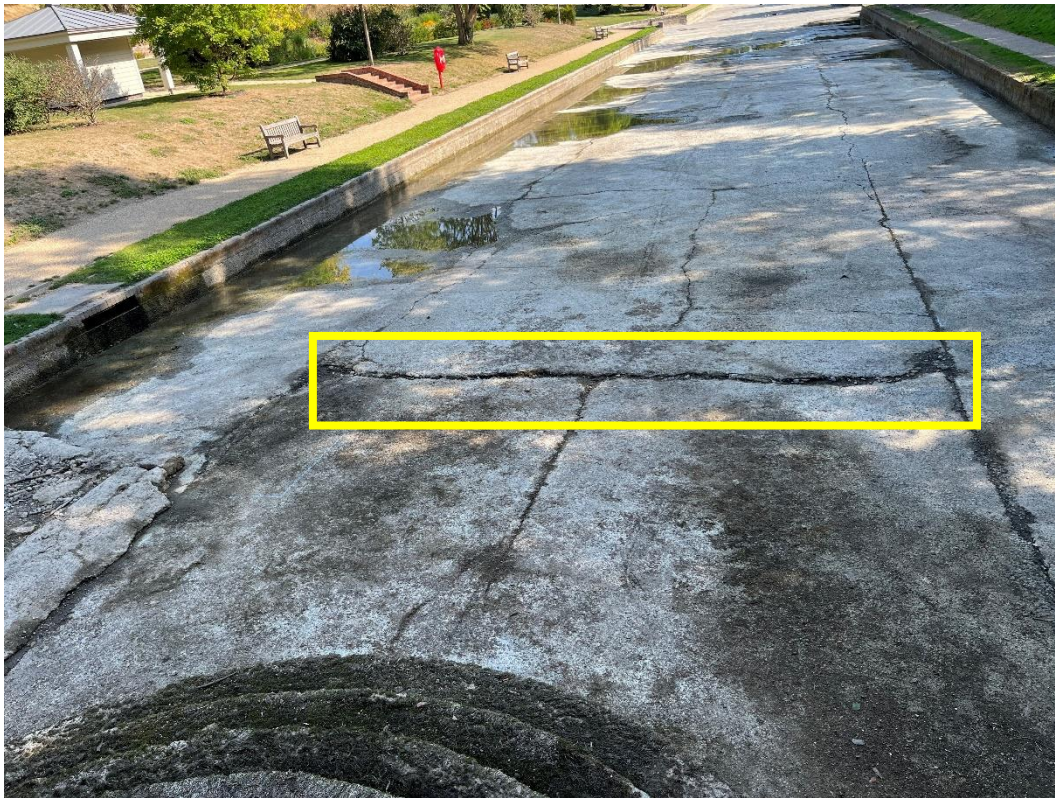
Plate 1 – View from upstream end of pond showing cracking and voided area A15.

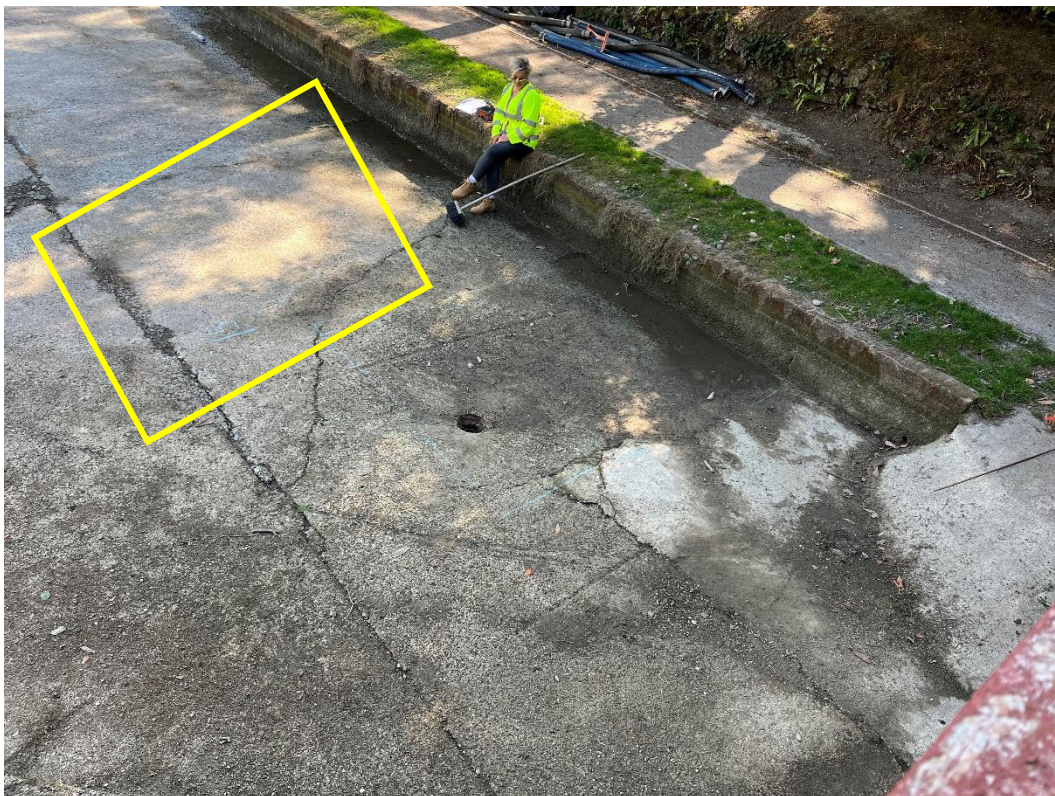
Plate 2 – View to upstream end of pond showing voided area A12.

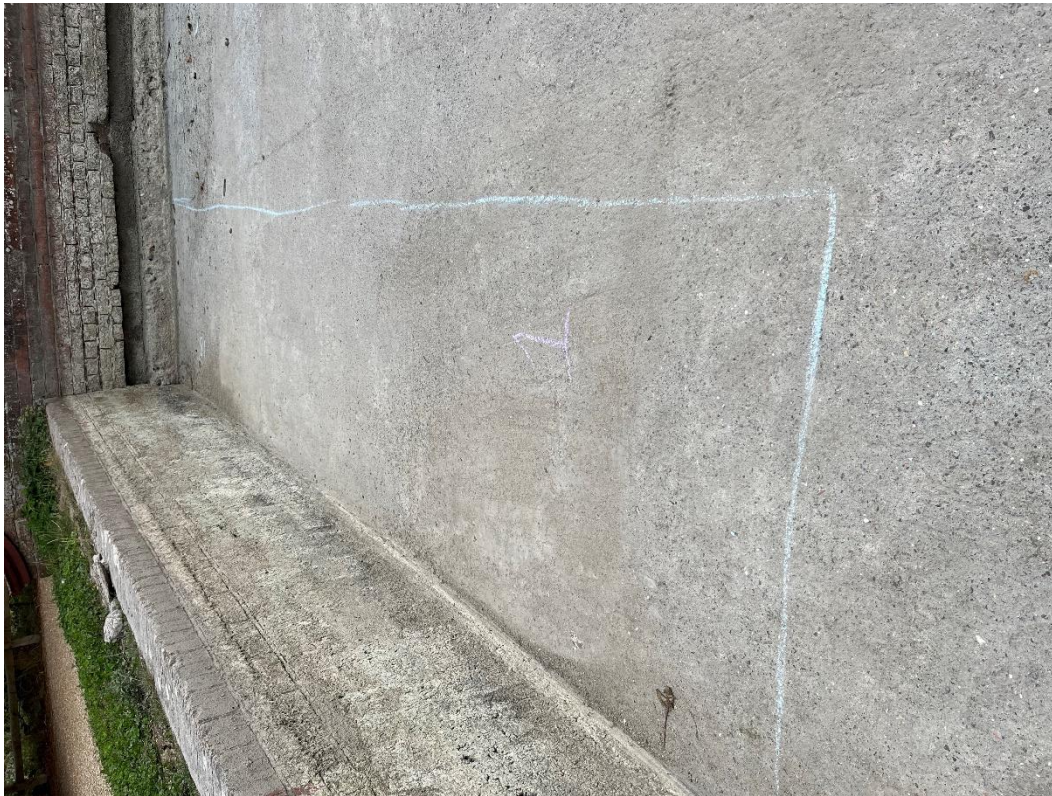
Plate 3 – Showing voided area to downstream end of pond at area A1.

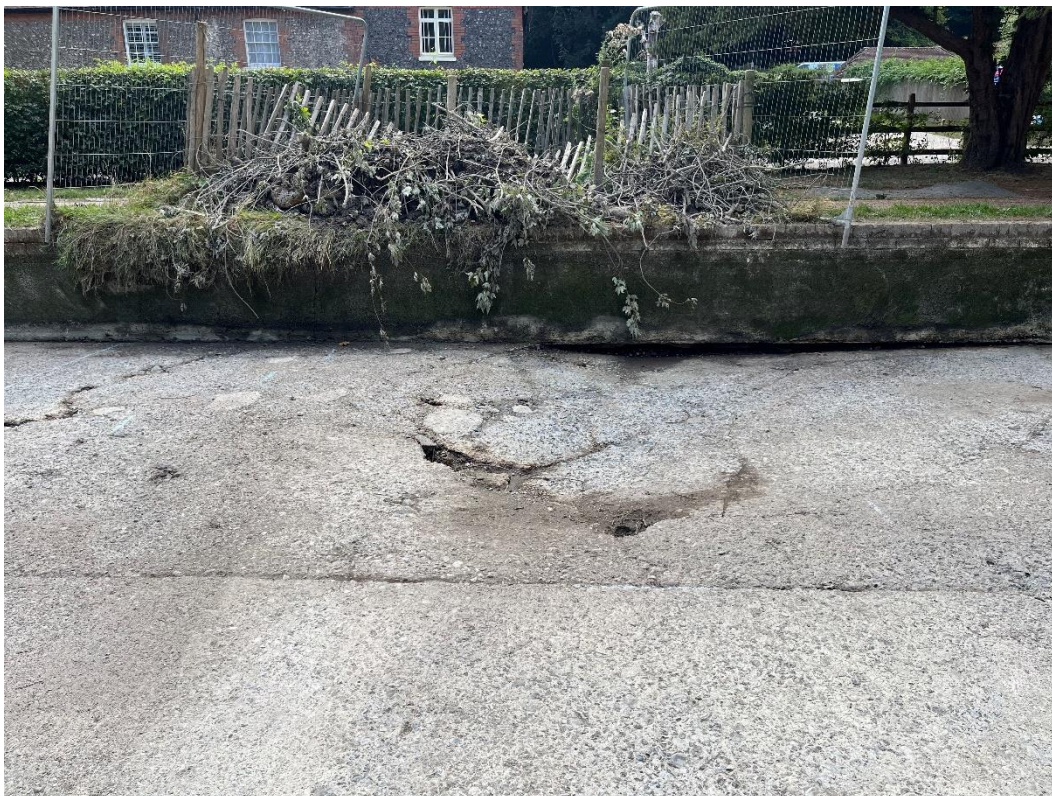
Plate 4 – Showing voided area and failed slab to area A4.

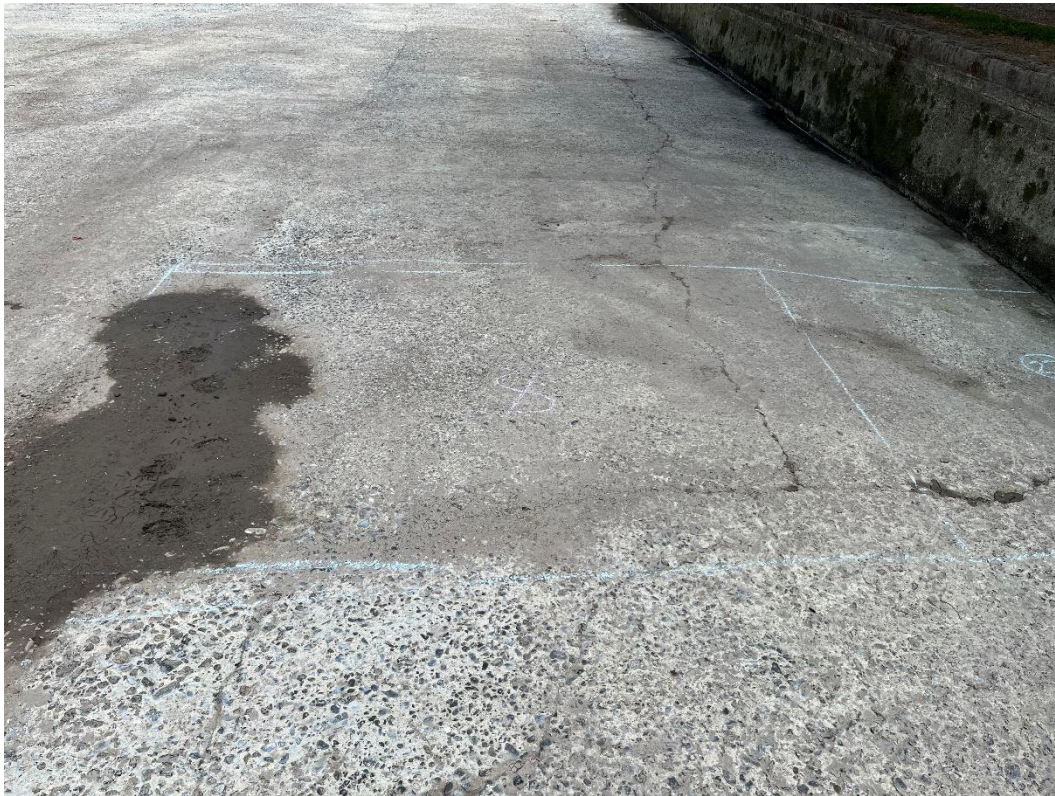
Plate 5 – Voided area to slab at area A8.

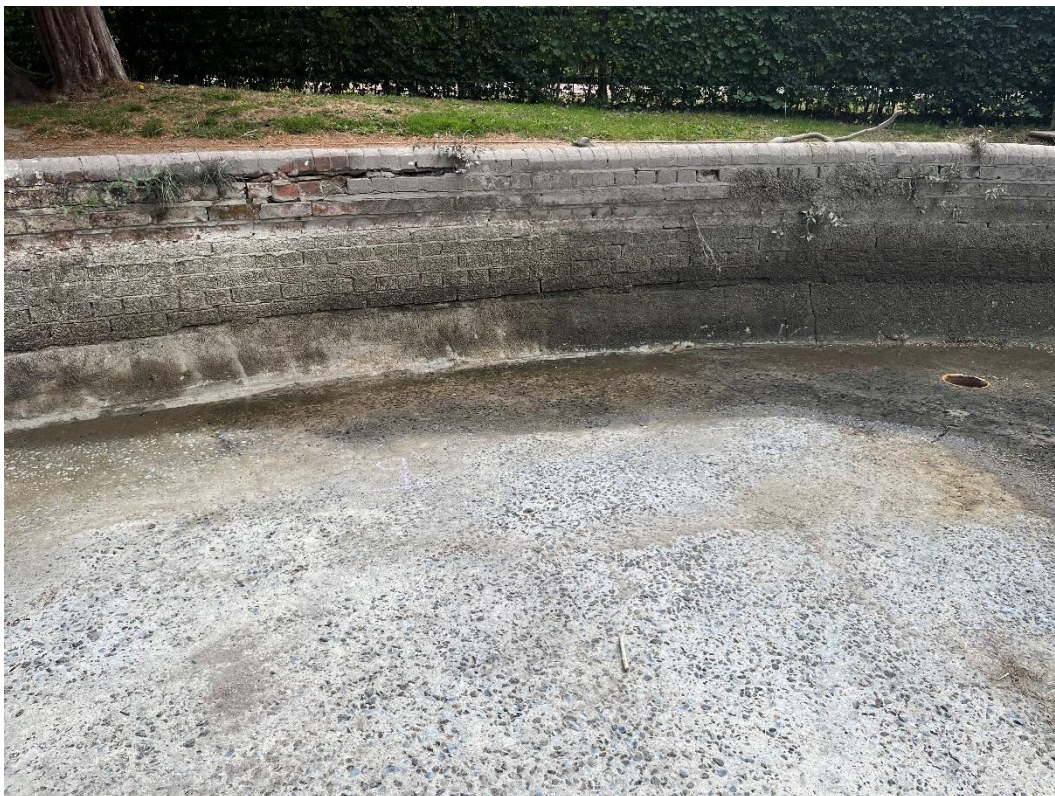
Plate 6 – Voided area to slab at area A9, adjacent to pond wall.

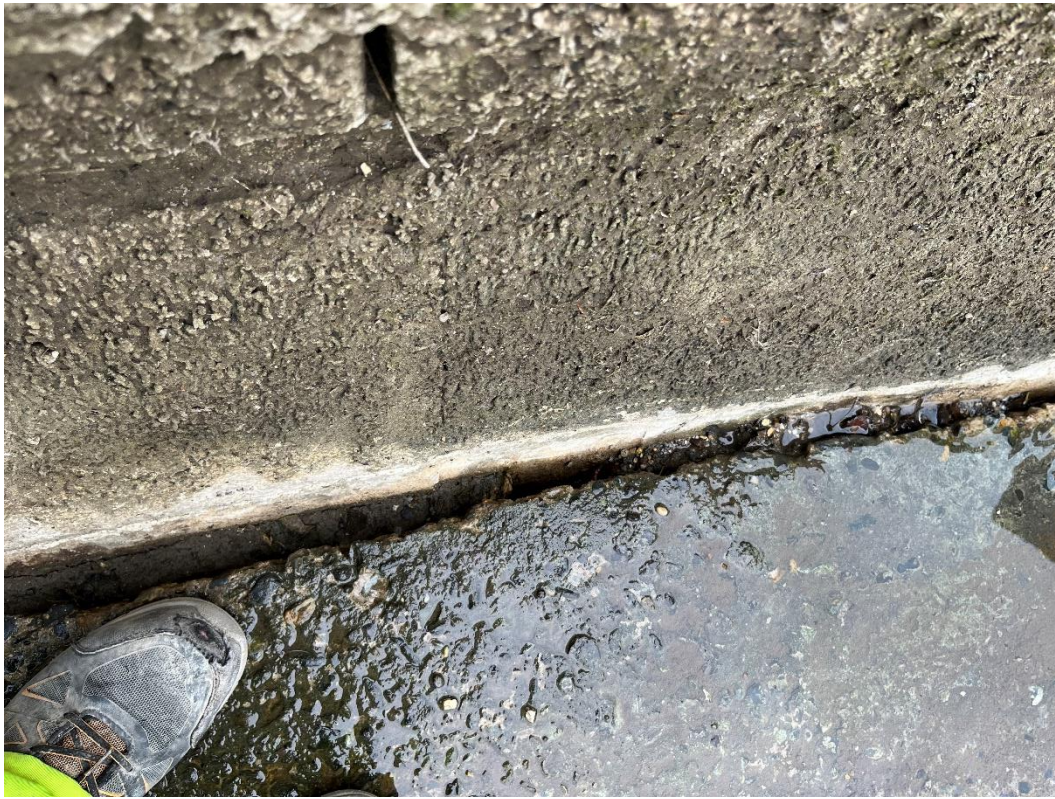
Plate 7 – Voidage at wall / slab interface at area A9.

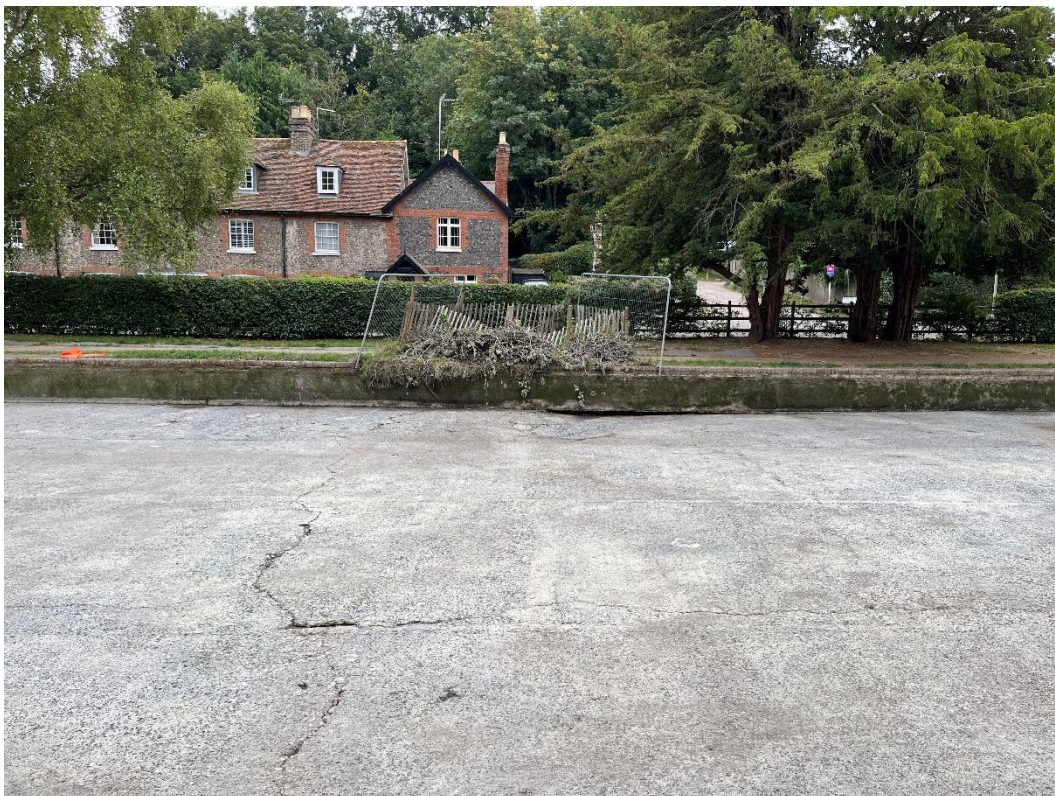
Plate 8 – General view to sinkage and voidage at area A4.

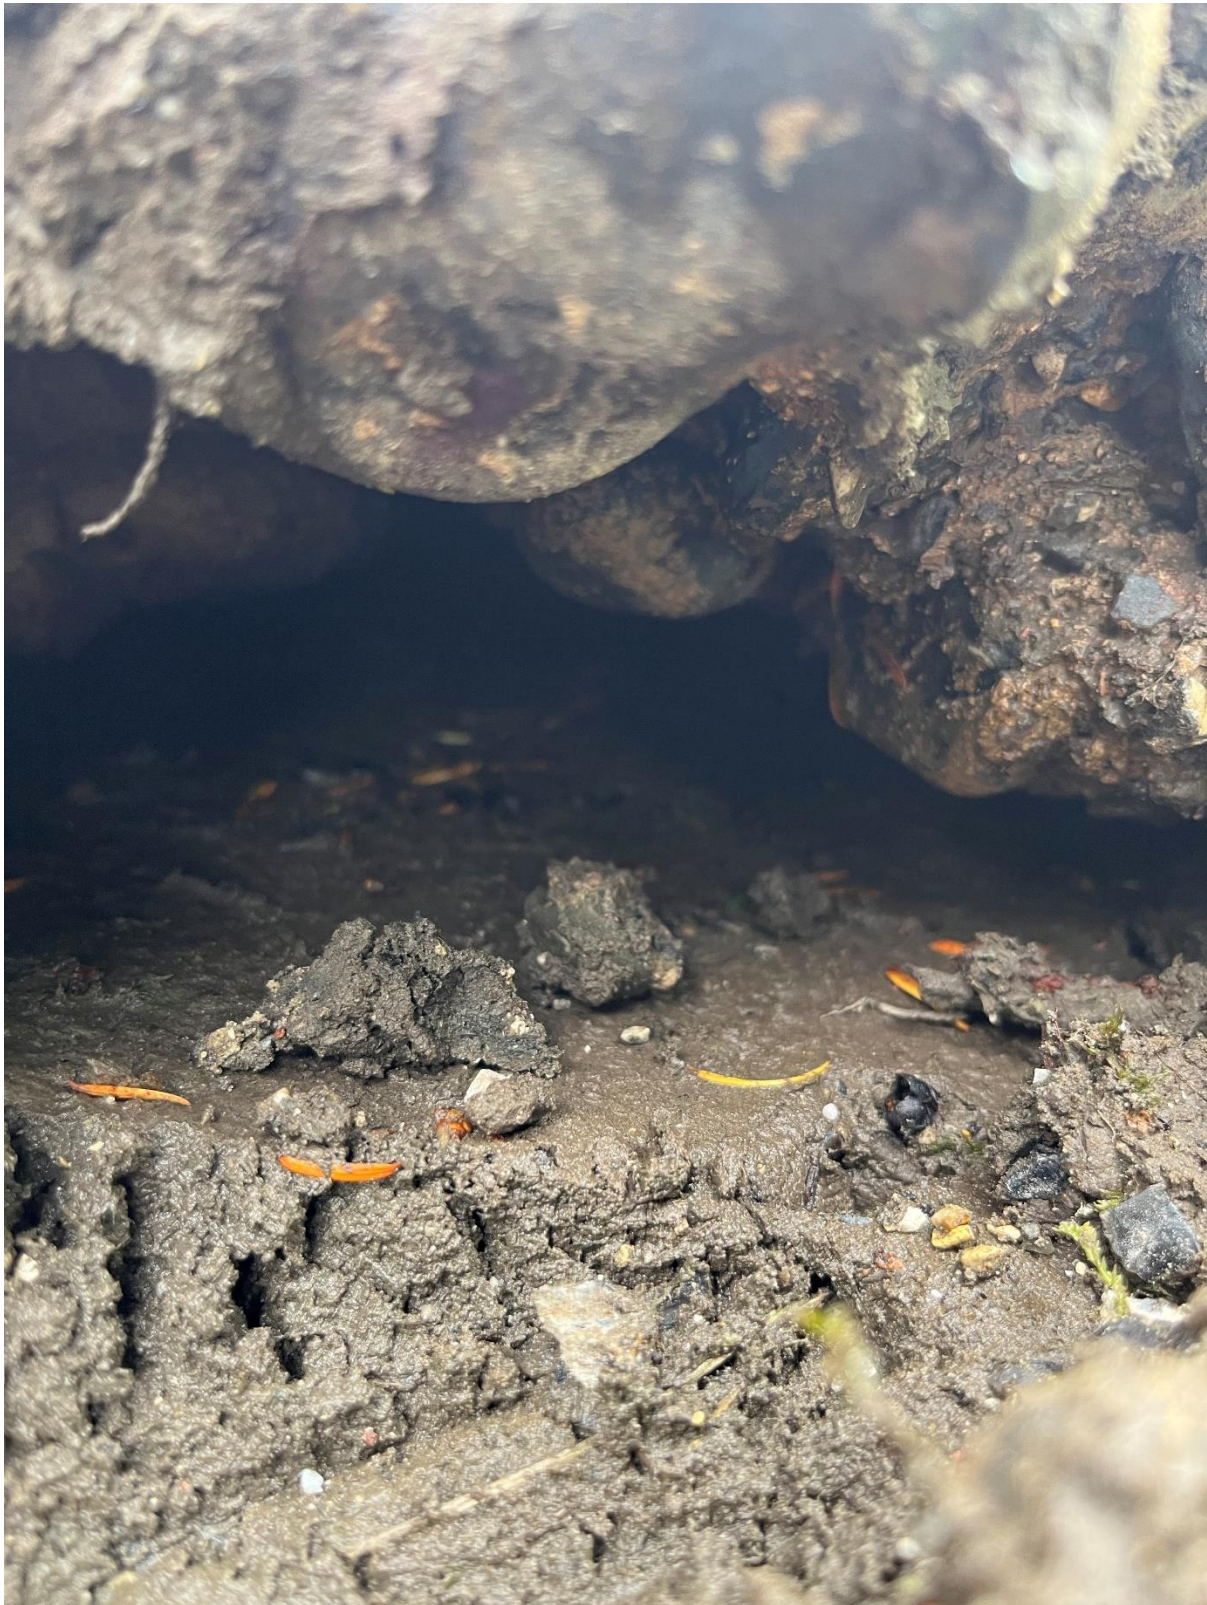
Plate 9 – Wash out and voidage at sinkage area to area A4.
