Flood Investigation Report

**Albert Road – Deal
Dover**

**Kent
County
Council**
kent.gov.uk

A flood event occurred on 21st May 2014 at Albert Road, Deal. The flood event caused damage to six properties.

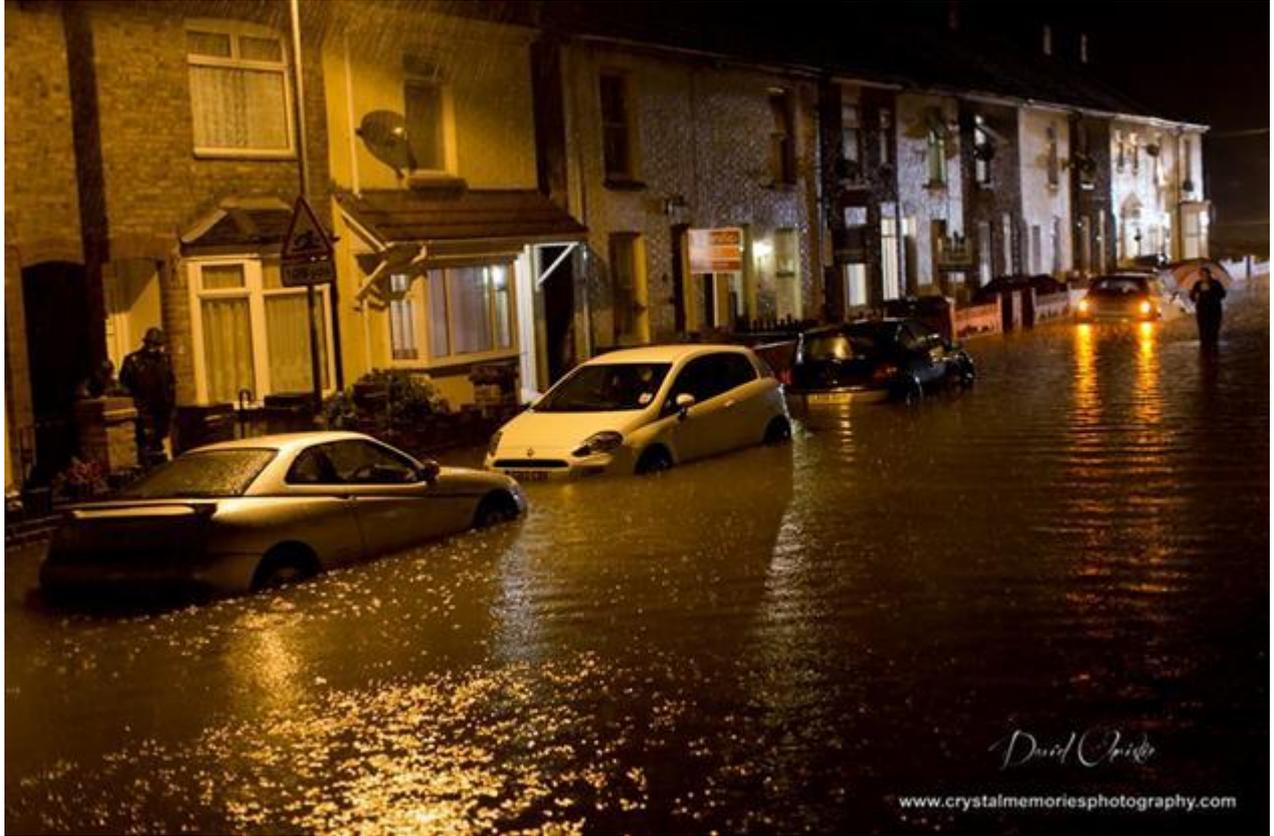
Figure 2 Flooding at Albert Road on 21 May 2014

On the 21st May 2014 it was reported to Kent County Council that Albert Road, Deal, shown in Figure 1 had flooded. Photo 1 shows the flooding that was experienced.

The flooding followed a period of heavy rainfall and resulted in damage to several properties on Albert Road and flooding on the road, estimated to be approximately 30cm deep. Six properties were flooded internally, and damage was reported to properties and vehicles.
